# **TRADITIONAL TOOLS AND MODERN TECHNOLOGIES FOR THE ANALYSIS OF MASONRY STRUCTURES:**

## **the case of the Church of Saint Andrea in Anagni**

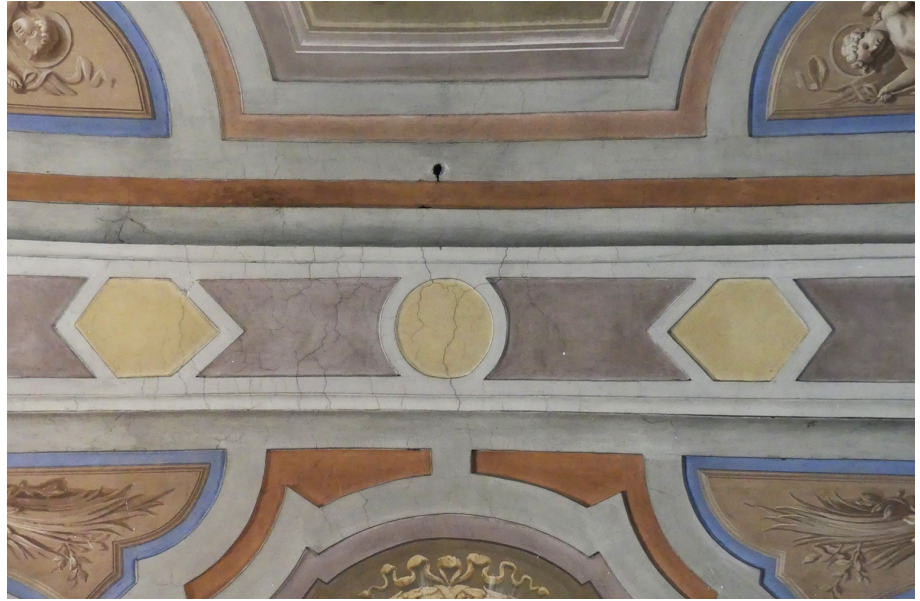
Cover picture:  
crack pattern of a masonry barrel vault.

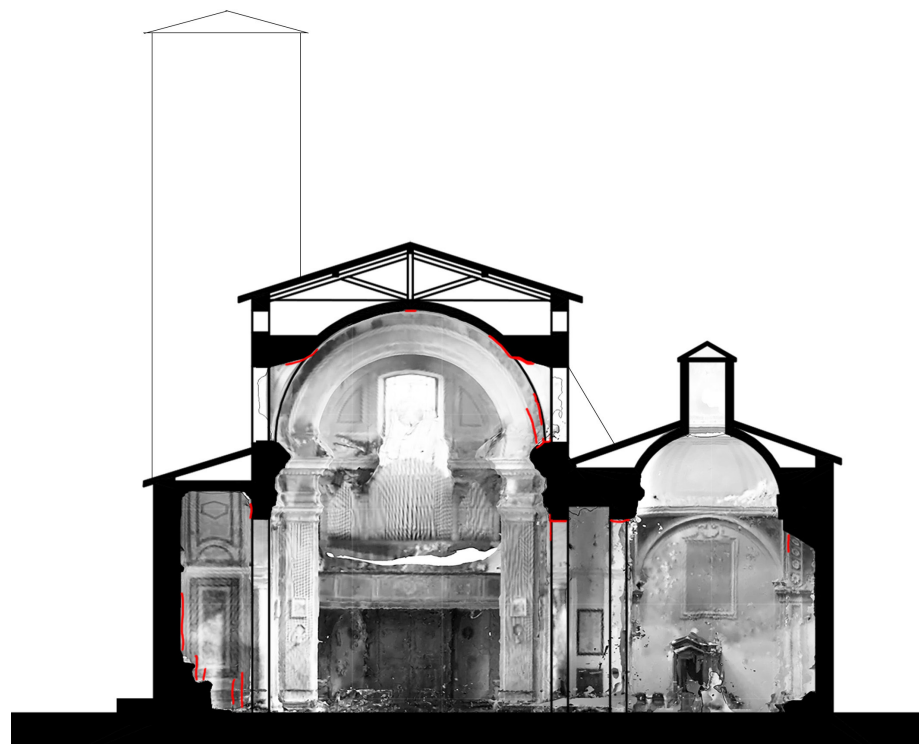
A consistent crack pattern is generally visible along the nave, the arches and the lateral chapels (figure 6, 7). Several cracks start in the lunettes, and in some cases, they extend towards the vault of the central nave, e.g., Lu-I or Lu-II lunette. In other cases, cracks run from the arch's keystone to the base of the lunette's windows, passing through the masonry wall between them.

Thus, as in the case of the Lu-I lunette and L-I arch, a more detailed observation highlights the existence of settlements that involve several structural elements. Moreover, cracks are registered in L-I, L-II, L-III and L-IV lateral arches. The barrel vault of the nave presents a diffuse and coherent crack pattern; here, cracks are oriented along the nave's axial direction and placed in correspondence to the keystone of all arches (I, II, III and IV). Such a cracks pattern could denote an overall settlement of the structure, and the presence of hinges visible from the church's extrados could confirm this hypothesis (figure 8 (a)). Despite that, the investigations conducted from the nave's extrados have not revealed the presence of cracks or other damages. Further, no particular geometrical deformations are recorded through the survey carried out. Only in correspondence of II arch a geometric variation of the arch itself and its supporting pillar is documented. Indeed, by combining the information obtained by photogrammetric and laser scanning survey with the one executed using a total station, it has been possible to observe a geometric variation of the arch II of about 9 centimeters lower with respect to the other arches.

7. AA section of Saint Andrea church. Highlighted in red are cracks.

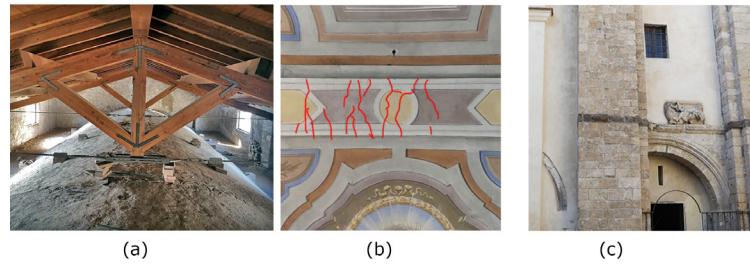
**8. (a)** extrados of barrel vault of Saint Andrea church; **(b)** intrados of the II arch; **(c)** particular of the south facade where different historical layers are still visible.

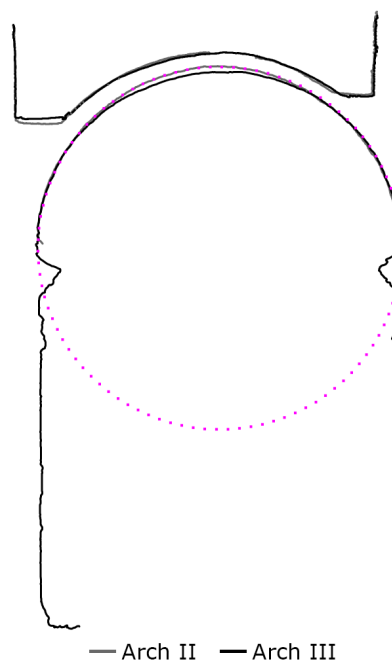
All arches I, II, III, IV have cracks in the keystone, but only arch II shows a significant geometrical alteration. Compared to a circle traced using arches I and III (figure 10), arch II presents a lowering of about 9 centimeters near the keystone and on the west side. Despite that, no cracks related to its settlement concerning other structural elements are readable. Therefore, it is reasonable to think that the settlement occurred in the early stages of its construction or, more likely, before the last renovation when all visible cracks were closed, and since that, no significant movements have occurred. For this reason, the analysis carried out has focused on establishing the state of the structures located in correspondence with arch II.

**10.** Comparison between arch II and arch III.

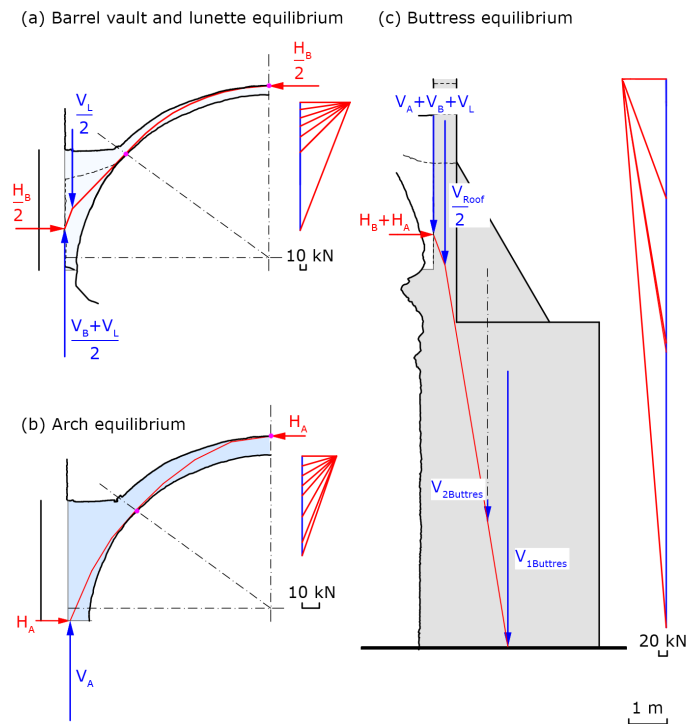
The vault has a thickness of 25 centimeters, the arch is 38 centimeters thick, and masonry was assumed to have a specific weight of  $15 \text{ kN/m}^3$ . Thus, using a graphic statics approach, the horizontal thrusts computed are  $H_A = 19.9 \text{ kN}$  and  $H_B = 87.8 \text{ kN}$  (figure 13). The arch's weight is  $113.4 \text{ kN}$ ; thus, on each pillar, it acts  $V_A = 56.7 \text{ kN}$ . The vertical load related to the portion of the barrel vault and lunettes is  $V_B + V_L = 234.88 \text{ kN}$ .

**13.** Thrust lines of barrel vault **(a)**, arch **(b)** and evaluation of the buttress equilibrium **(c)**.

For all vertical structures (pillar and buttress), a specific weight of  $18.5 \text{ kN/m}^3$  was assumed. Therefore, the overall equilibrium has been carried out using graphic statics tools. The specific weight includes the wall's material, the roof's contribution, the fillings, and other structural components which load on the vertical elements investigated. The structural state of the structure was assessed by evaluating the Geometrical Safety Factor (GSF) (Heyman, 1966). Considering a section, the GSF is defined by the ratio between the section's half thickness and the distance from the point where the TL intersects the chosen section to the section's central point. Usually, a safe structure presents a GSF equal to 3 or higher in all sections [22]; in general, high values denote safer sections. In the case investigated at the buttress base, the GSF corresponds to 9.7. Furthermore, in all vertical structures analysed (pillar and buttress), the thrust lies within the thickness; therefore, the section is safe, and no overturning can occur.
