# **TRADITIONAL TOOLS AND MODERN TECHNOLOGIES FOR THE ANALYSIS OF MASONRY STRUCTURES:**

## **the case of the Church of Saint Andrea in Anagni**

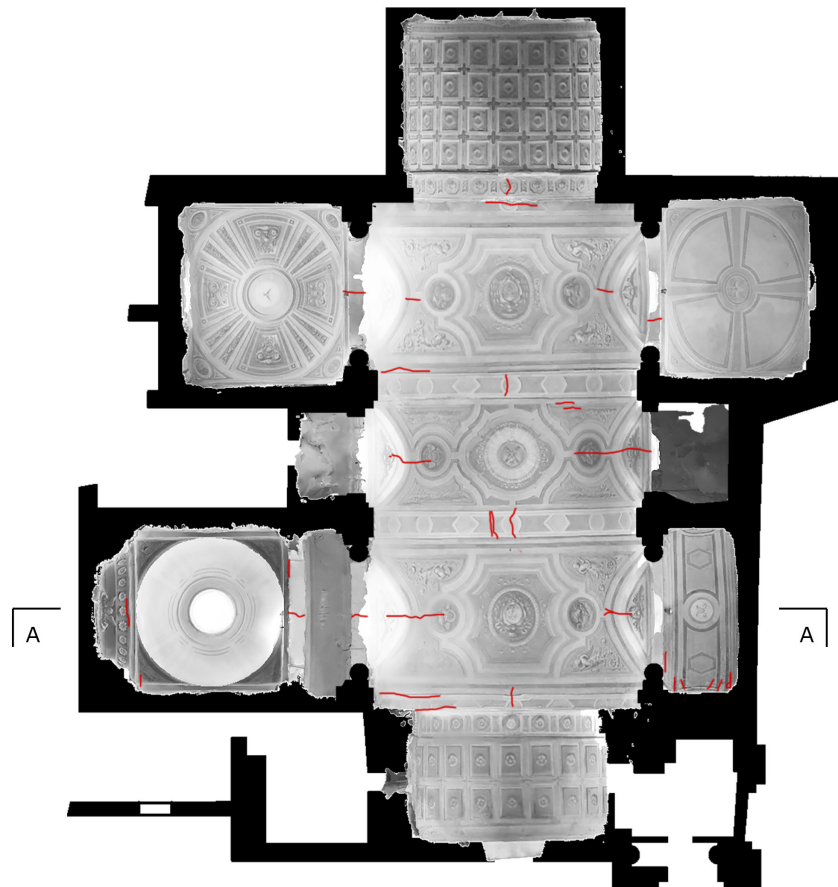
6. Plan view of Saint Andrea church (from bottom to top), plan view of barrel vaults, arches, domes and lunettes.

A consistent crack pattern is generally visible along the nave, the arches and the lateral chapels (figure 6, 7). Several cracks start in the lunettes, and in some cases, they extend towards the vault of the central nave, e.g., Lu-I or Lu-II lunette. In other cases, cracks run from the arch's keystone to the base of the lunette's windows, passing through the masonry wall between them.

Thus, as in the case of the Lu-I lunette and L-I arch, a more detailed observation highlights the existence of settlements that involve several structural elements. Moreover, cracks are registered in L-I, L-II, L-III and L-IV lateral arches. The barrel vault of the nave presents a diffuse and coherent crack pattern; here, cracks are oriented along the nave's axial direction and placed in correspondence to the keystone of all arches (I, II, III and IV). Such a cracks pattern could denote an overall settlement of the structure, and the presence of hinges visible from the church's extrados could confirm this hypothesis (figure 8 (a)). Despite that, the investigations conducted from the nave's extrados have not revealed the presence of cracks or other damages. Further, no particular geometrical deformations are recorded through the survey carried out. Only in correspondence of II arch a geometric variation of the arch itself and its supporting pillar is documented. Indeed, by combining the information obtained by photogrammetric and laser scanning survey with the one executed using a total station, it has been possible to observe a geometric variation of the arch II of about 9 centimeters lower with respect to the other arches.

The historical alteration over centuries of the church of Saint Andrea could explain the crack pattern described above (figure 6). Two historical changes are deemed to have a non-negligible structural influence: the enlargement of the presbytery with the elevation of the bell tower that occurred in the 13th century; and the renovation of the 18th century. Thus, the church was considerably enlarged and elevated in both renovations, probably leading to the formation of the crack pattern observable today. From historical investigations, the original Romanic vaults were demolished and additional buildings were inglobated to the Saint Andrea Church. In this logic, the cracks observed in the presbytery zone can be reasonably associated with the structural enlargement and the following settlements, as well as the big transversal crack located on the top of arch IV and the longitudinal crack on arch III. Indeed, potential geotechnical issues derived from elevations or geometric alterations of the structure could have induced differential settlements and thus led to diffuse cracks. Analogue reasons can justify the vertical cracks (figure 7) present in the secondary chapel connected to the bell tower and the one observable on the front-façade. These vertical cracks are typical examples of the detachment of structural elements built in different periods and not adequately connected [20]. Also, the keystone crack probably was caused by additional structures built for the bell tower's elevation.

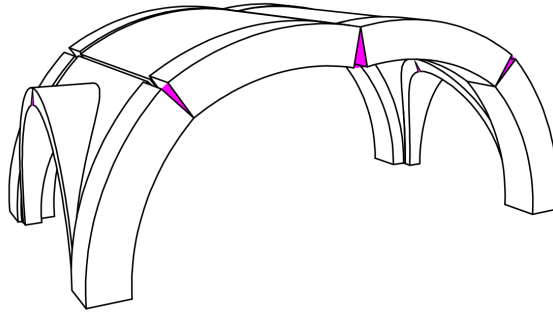
**11.** Model of the analyzed structure. Highlighted in purple are the hinges.

Analyses were performed assuming the existence of three hinges, whose position was compatible with the crack pattern discussed above. Thus, arch II and the portion of the barrel vault analyzed have been divided by three hinges. For both elements, the first hinge is placed at the extrados of the keystone, and the other two, symmetrically placed, are positioned at the intrados near the lunettes keystone (figure 11).

In this manner, arch II and the portion of barrel vault analyzed assume a configuration of minimum thrust, i.e. the horizontal thrust transmitted to the pillars and buttress has the minimum magnitude. As pointed out in [21], the presence of a crack does not imply instability but, more simply, a new equilibrium configuration (a three-hinge arch in this case) that allows the masonry structure to stand. Indeed, for both cracked structures, only one thrust line (TL) can pass through all three hinges, and solely if the TL entirely lies within the intrados and extrados, the equilibrium can be achieved. Thus, the portion of the Saint Andrea Church (6.5 meters long) analyzed during the investigation interests arch II, a portion of the barrel vault and lunettes. Furthermore, in order to estimate the balance of the entire critical section of the structure, the east vertical structures (pillar and buttress) on which arch II transfers loads have been also analyzed (figure 12).

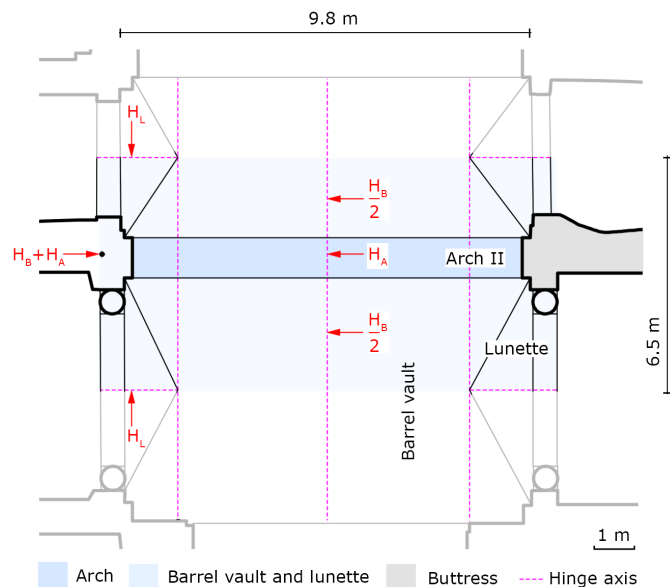
**12.** Plan view of the structure's portion analyzed (from bottom to top).

Several horizontal thrusts act on the top of the pillar, the lunette's ones indicated with  $H_L$ , the thrust of the barrel vault indicated with  $H_B$ , and the one related to arch II labelled with  $H_A$ . Due to the geometry, the two  $H_L$  were assumed to be equal and opposite; thus, it is required to estimate  $H_A$  and  $H_B$  only.

In the context of the conducted research, the survey and the historical analysis have highlighted a peculiar configuration of arch II. Thus, the structural analysis has focused on assessing the state of the vault-arch II-pillar-buttress system from a static point of view by computing the TL and individuating the GSF. Therefore, this expeditious analysis permits to remark that the observed crack pattern on arch II has minimal relevance to the whole stability of the system.
